) Bankruptcy Case No.: 19-30088 (DM)
) Chapter 11
) (Lead Case) (Jointly Administered)
)
) RESPONSE TO THE NOTICE OF THE
) REORGANIZED DEBTORS' FORTY-THIRD
) OMNIBUS OBJECTION TO CLAIMS
) REPORT OF ARBORIST (Correction)
)
) **DATE: December 15, 2020**
) **TIME: 10:00 a.m. (Pacific Time)**
)
) **PLACE: (Telephonic Appearances Only)**
) **United States Bankruptcy Court**
) **Courtroom: 17, 16th Floor**
) **San Francisco, CA 94102**

Subject: Trees at 1721 N. Recreation Avenue, Fresno, CA

Tree Assessment & Appraisal

Residential Property at
1721 N. Recreation Ave., Fresno, CA

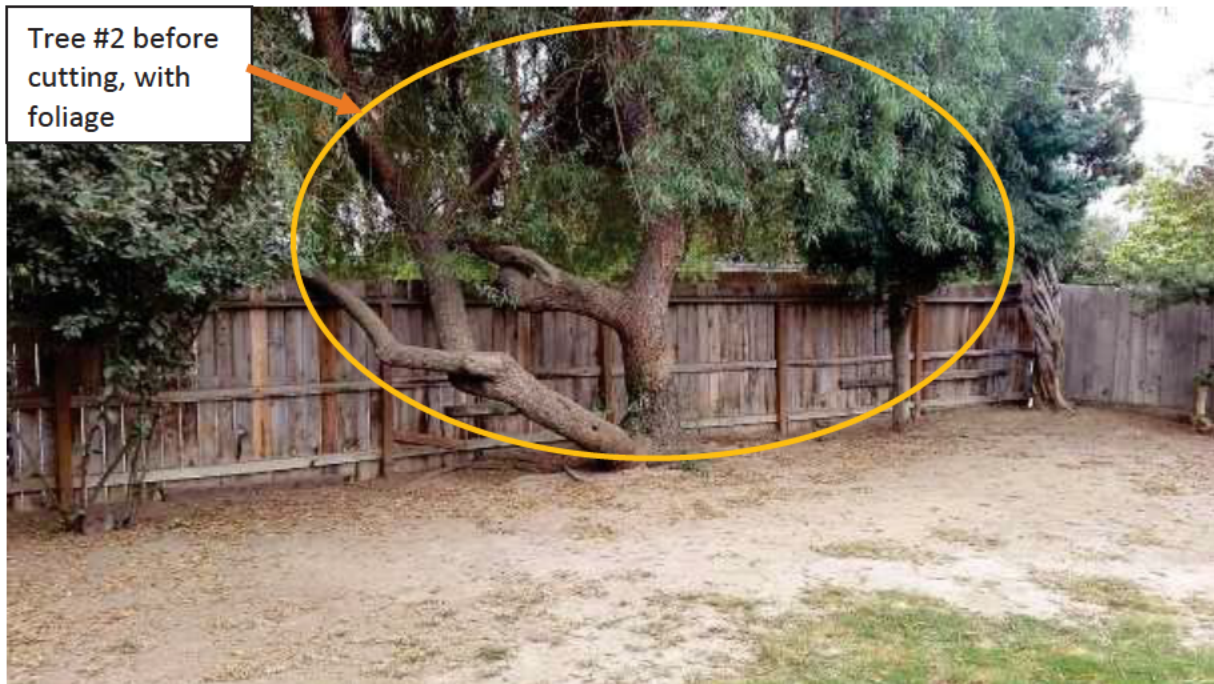
Photo 9

Tree #3, a Fern Pine, has a DBH of 6 inches. The branches of this tree were headed back to approximately 10 feet from the ground. It is a young tree with good vigor. About 60% of the trees foliage prior to cutting remains (see Appendix A, Photo 9).
